**Flood Control Project Maintenance  
Levee Inspections**

## Maintenance Issue Types Only, Levee Inspection Report By Mile - Spring 2019

### Sutter Maintenance Yard Maintenance Area 0007

Waterway	Bank	Unit Miles	Inspection Start/End	Inspector
Unit No. 01 Feather River	Right	11.90	04/04/2019 04/04/2019	Sterling York

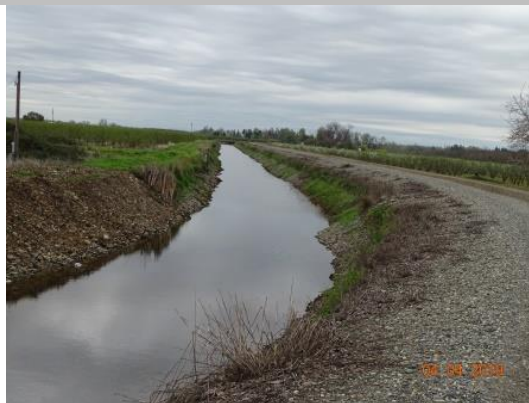
Photo 1 of 1 : SP\_2019\_MA0007\_200\_10\_20190409\_00028.jpg

LM Start	0.00	Rating **	A	Issue No.	10
LM End	11.89	Issue Type +	Ma	Location *	LS
Category	Earthen Levee			GPS Latitude/Longitude	
				Start	End
Item	Vegetation			39.310938 °	39.439672 °
				-121.637634 °	-121.641504 °
DWR ID	DWR_MA0007_01_s_2019_10				
Comment Code					
V1 : Control annual grass and weeds on the levee slopes and easements.					
Inspector Comment					
The annual vegetation is well maintained, Spring 2019.

View looking upstream landside at the well maintained vegetation alongside the irrigation ditch, Spring 2019.

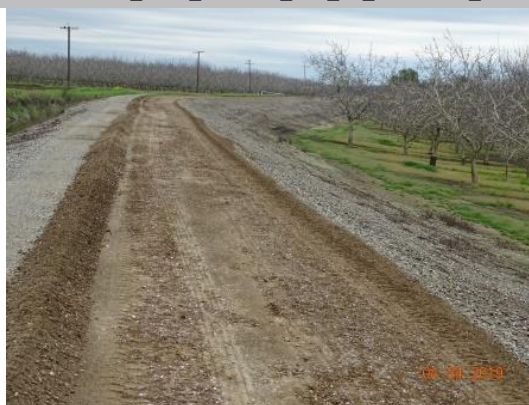
Photo 1 of 1 : SP\_2019\_MA0007\_200\_11\_20190409\_00029.jpg

LM Start	0.00	Rating **	A	Issue No.	11	
LM End	11.89	Issue Type +	Ma	Location *	WS	
Category	Earthen Levee			GPS Latitude/Longitude		
				Start	End	
Item	Vegetation			39.310938 °	39.439672 °	
				-121.637634 °	-121.641504 °	
DWR ID	DWR_MA0007_01_s_2019_11					
Comment Code						
V1 : Control annual grass and weeds on the levee slopes and easements.						
Inspector Comment						
The annual vegetation is well maintained, Spring 2019.

View looking upstream waterside at the well maintained vegetation and re-grading of the levee crown, Spring 2019.

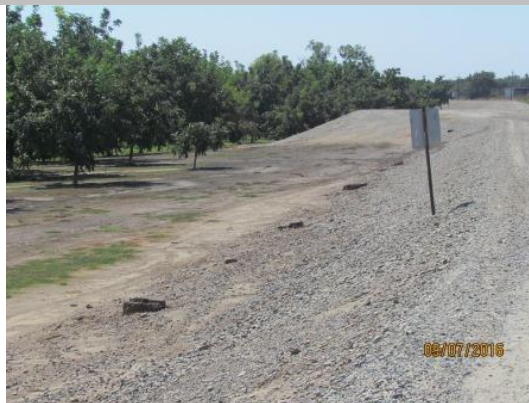
Photo 1 of 1 : SP\_2019\_MA0007\_200\_69\_20190305\_00009.jpg

LM Start	0.31	Rating **	N	Issue No.	69
LM End	0.37	Issue Type +	Ma	Location *	WS
Category	Earthen Levee			GPS Latitude/Longitude	
				Start	End
Item	Trim / Thin Trees			39.314991 °	39.315693 °
				-121.635038 °	-121.634459 °
DWR ID	DWR_MA0007_01_s _ 2016_69				
Comment Code					
T5 : Tree stumps.					
Inspector Comment					
Several tree stumps at levee toe still exist Fall 2018.

View looking downstream of several tree stumps at the levee toe on the waterside.

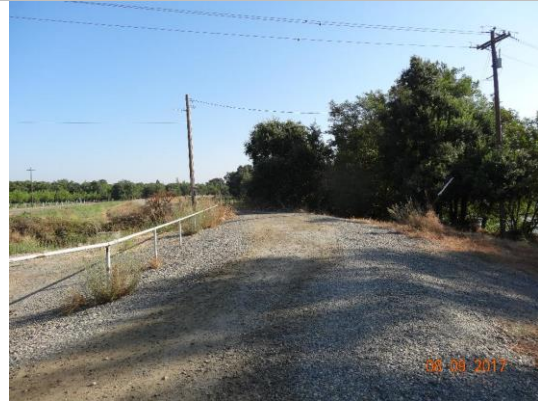
Photo 1 of 3 : UCIP\_SP\_2019\_53950\_77346.jpg

FS\_ID:53950  
DS\_ID:16926  
EP\_NO: N/A  
Repair Type: Non-Urgent  
Crossing Status: Found  
UCIP Comments: 05/07/2019 (O. Magana - DWR UCIP)12/07/2018 Encroachment Owner is Butte Water District c/o Mark Orme, District Manager, 735 Virginia Street, Gridley, CA 95948, 1-530-846-3100. Information obtained from the Levee\_Encroachment\_listing\_11288.pdf obtained from SBFCA which also indicates CVFPB Permit Process - New Permit. Need to coordinate with CVFPB to determine status of permit. (O. Magana - DWR UCIP)  
08/09/2017 Dual 60-inch pipes are still present--no modifications appear to have been made to this structure. No permit or owner has been identified. Need to contact owner to notify of safety issue regarding the missing covers for CMP riser. (DWR UCIP - O. Magana)08/02/2017 After reviewing record drawings it appears this crossing has remained. Project Improvements begin at Station (Sta) 1765+00 (MA0007 about LM 1.73) to Sta 2303+50 (ST0005 about LM 1.23), refer to record drawings for the Feather River West Levee Improvement Plans Station 1765+00 to 2368+26, Project D details. MA0007 project details include NO CUTOFF WALL from Sta 1765+00 (MA0007 about LM 1.73) to 1815+00 (MA0007 about LM 2.64) and LEVEE DEGRADE AND RECONSTRUCTION WITH CUT OFF WALL from Sta 1817+00 (MA0007 about LM 2.69) to Sta 2289+00, Sta 2287+00 to Sta 2290+00 (MA0007 about LM 11.60). (DWR UCIP - O. Magana)

05/16/2016 Feather River West Levee Improvement Project--Levee currently under construction.06/10/2015 Debris still present in risers and pipes were not replaced with the SBFCA project.12/29/2014 Same as last inspection.05/19/2014 Same as last inspection.11/06/2013 Same as last inspection.05/13/2013 SBFCA project recommends replacing in accordance with title 23.05/07/2013 Same debris issue as last inspection. Recommend repairing top cover to prevent falls. Wheel to open gate chained and locked so could not verify gate operation.10/31/2012 Debris inside riser could prevent slide gate from closing. This crossing was listed in the USACE Periodic Inspections as ID# USACE\_CESPK\_MA07\_2010\_a\_0060 however, no issues noted. (DWR UCIP - O. Magana)  
FIELD\_STRUCT\_DESC: 1 of 2: 60-inch corrugated metal gravity drainage pipe through the levee, 12.5 feet below the crown. Slide gate in a 78-inch corrugated metal pipe (CMP) well on the waterside (WS) slope. Concrete bulkheads on both ends. Reinforced concrete spillway on the WS end. (Existing 60-inch corrugated metal gravity drainage pipe crossing remained during the Feather River West Levee Improvements, Project D). [Additional Reference(s): DWR Levee Log, 2005. USACE Sacramento O&M Manual 152, March 1957 (Station

Overview of levee crown looking upstream towards crossings.

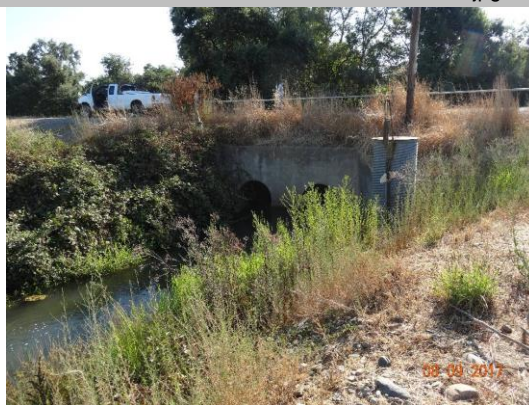
Photo 2 of 3 : UCIP\_SP\_2019\_53950\_77351.jpg

LS view: concrete headwall with dual 60-inch crossings visible from LS.

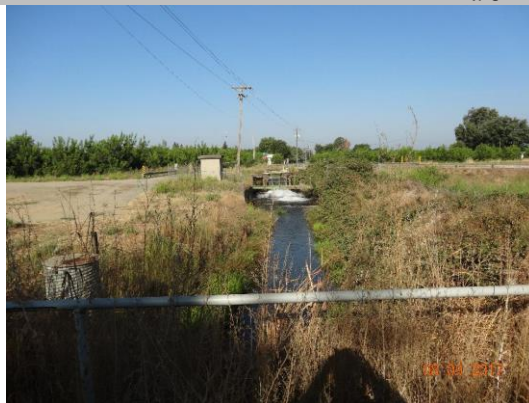
Photo 3 of 3 : UCIP\_SP\_2019\_53950\_77342.jpg

LS view: view of canal looking west from crossing.

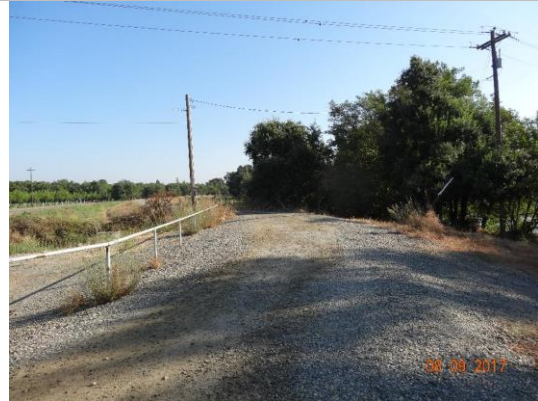
Photo 1 of 3 : UCIP\_SP\_2019\_53951\_77352.jpg

FS\_ID:53951  
DS\_ID:17011  
EP\_NO: N/A  
Repair Type: Non-Urgent  
Crossing Status: Found  
UCIP Comments: 12/07/2018 Encroachment Owner is Butte Water District c/o Mark Orme, District Manager, 735 Virginia Street, Gridley, CA 95948, 1-530-846-3100. Information obtained from the Levee\_Encroachment\_listing\_11288.pdf obtained from SBFCA which also indicates CVFPB Permit Process - New Permit. Need to coordinate with CVFPB to determine status of permit. (O. Magana - DWR UCIP) 08/09/2017 Dual 60-inch pipes are still present--no modifications appear to have been made to this structure. No permit or owner has been identified. Need to contact owner to notify of safety issue regarding the missing covers for CMP riser. (DWR UCIP - O. Magana) 08/02/2017 After reviewing record drawings it appears this crossing has remained. Project Improvements begin at Station (Sta) 1765+00 (MA0007 about LM 1.73) to Sta 2303+50 (ST0005 about LM 1.23), refer to record drawings for the Feather River West Levee Improvement Plans Station 1765+00 to 2368+26, Project D details. MA0007 project details include NO CUTOFF WALL from Sta 1765+00 (MA0007 about LM 1.73) to 1815+00 (MA0007 about LM 2.64) and LEVEE DEGRADE AND RECONSTRUCTION WITH CUT OFF WALL from Sta 1817+00 (MA0007 about LM 2.69) to Sta 2289+00, Sta 2287+00 to Sta 2290+00 (MA0007 about LM 11.60). (DWR UCIP - O. Magana) 05/16/2016 Feather River West Levee Improvement Project--Levee currently under construction. 06/10/2015 Debris still present inside riser and pipe was not replaced with the SBFCA project. 12/29/2014 Same as last inspection. 05/19/2014 Same as last inspection. 11/06/2013 Same as last inspection. 05/13/2013 SBFCA project recommends replacing in accordance with title 23.05/07/2013 Same as last inspection. Recommend constructing cover to prevent falls. Wheel to operate gate chained and locked so gate operation could not be verified. 10/31/2012 no cover; debris inside riser could prevent slide gate from closing. This crossing was listed in the USACE Periodic Inspections as ID# USACE\_CESPK\_MA07\_2010\_a\_0060 however, no issues noted. (DWR UCIP - O. Magana) FIELD\_STRUCT\_DESC: 2 of 2: 60-inch corrugated metal gravity drainage pipe through the levee, 12.5 feet below the crown. Slide gate in a 78-inch corrugated metal pipe (CMP) well on the waterside (WS) slope. Concrete bulkheads on both ends. Reinforced concrete spillway on the WS end. (Existing 60-inch corrugated metal gravity drainage pipe crossing remained during the Feather River West Levee Improvements, Project D). [Additional Reference(s): DWR Levee Log, 2005. USACE Sacramento O&M Manual 152, March 1957 (Station 1+90). Sutter Butte Flood Control Agency (SBFCA) Feather River West

Overview of levee crown looking upstream towards crossings.

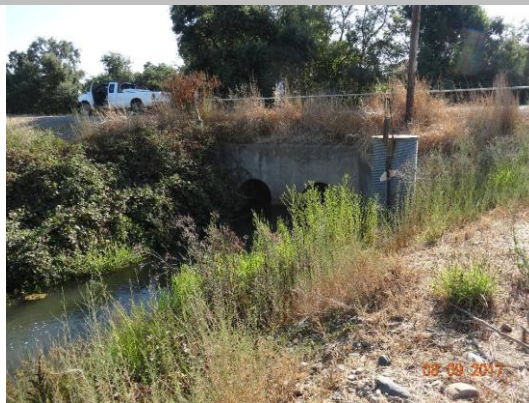
Photo 2 of 3 : UCIP\_SP\_2019\_53951\_77357.jpg

LS view: concrete headwall with dual 60-inch crossings.

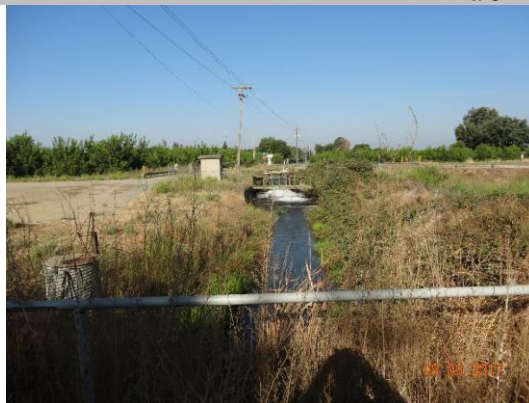
Photo 3 of 3 : UCIP\_SP\_2019\_53951\_77358.jpg

LS view: canal located on LS, photo taken from levee crown looking west.
